# Home Inspection

300 Sample Street  
300 Sample  
Omaha, Ne

Prepared for: John Doe

Prepared by: Home Standards Inspection Services  
13512 Shongaska Road  
Omaha, NE 68112

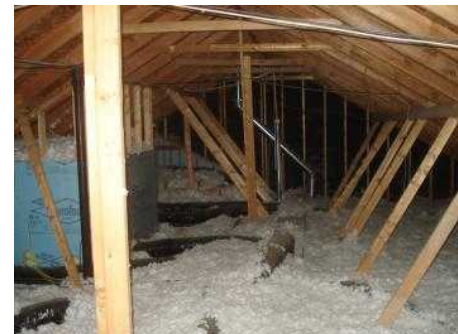
- Insulation Depth: **+14" Approx R35**
- Whole House Fan: **Note: Insulation at whole house fan. This must be removed prior to use. Could not test fan for this reason.**
- Electrical: **110 VAC**

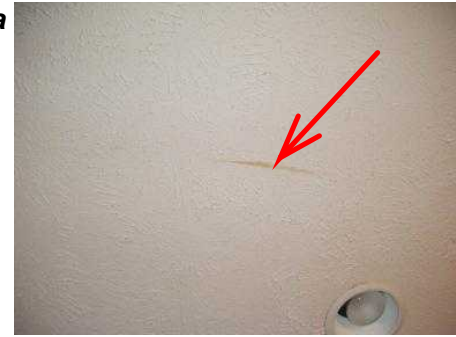
- Walls / Ceilings **Two water stains at ceiling of Kitchen. One area has minor drywall damage. Area tested dry today, appears to have been caused from snow blowing into roof vent. Suggest you ask owner about this.**

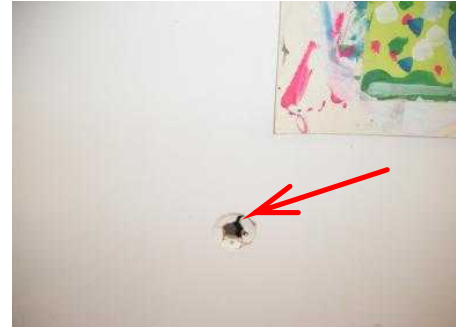
- Walls / Ceilings **Hole at drywall behind door.**

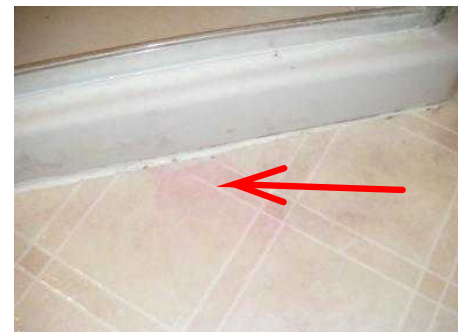
Toilets:  
 Shower/Surround: **Vinyl floor is discolored around shower, probably due to leakage from shower door.**

**Drywall stained, possible mold present at drywall next to shower. Drywall tested damp.**

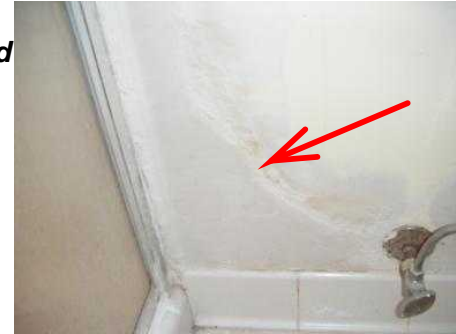
- Sink/Faucet/Vanity Top:
- Ceilings/Walls/Floors: **Finished Drywall next to shower has been repaired, appears there has leakage in this area. Potential mold present in area. Some parts of wall tested damp with moisture meter.**

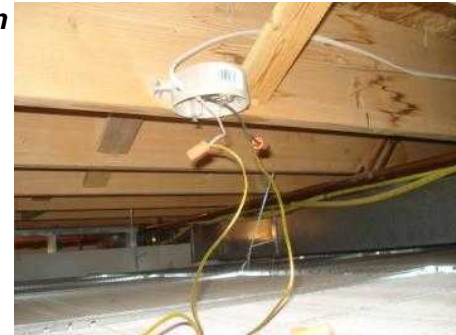
- Service: **Copper : Buried service line**
- 120 VAC Branch Circuits: **Copper Electrical splice out of junction box at storage room ceiling.**

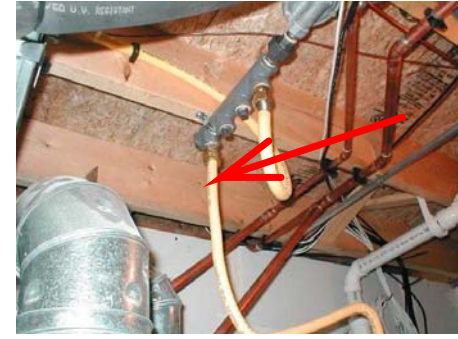
- Service Line: **Copper**
- Main Water Shutoff: **Basement**
- Water Lines: **Copper**
- Drain/Vent Pipes: **PVC**
- Gas Service Lines: **CSST Gas Pipe and Black Pipe. CSST Gas pipe used in home. Some local gas companies are requiring these pipes to be grounded, for safety concerns, due to lightning strikes. Recommend grounding by a licensed electrician or other licensed contractor.**

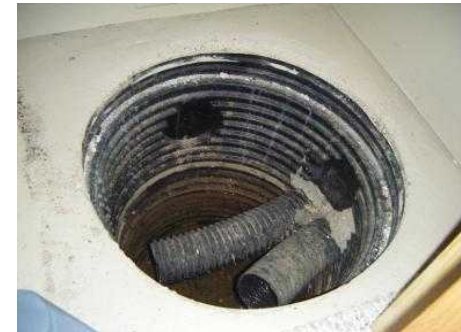
- Construction Type **Masonry and wood frame**
- Foundation Walls **Concrete block**
- Support Beams: **Steel I-Beam**
- Support Columns: **Steel Posts**
- Joists/Trusses **2" x 10"**
- Basement Stairs/Railings:
- Floor/Slab: **Concrete**
- Sump Pit/Pump: **Pit located at the basement floor - no pump installed. Sump pit has a significant amount of water in it, recommend a sump pump be installed.**

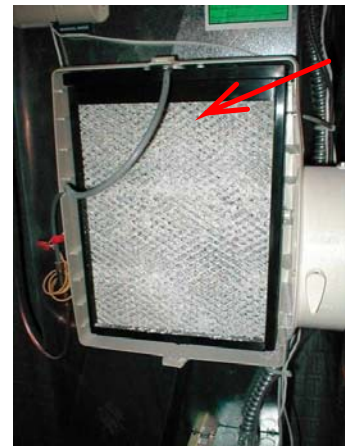
- Blower Fan/Filter:
- Flue Pipe:
- Controls:
- Humidifier: **The humidifier pad is corroded. Suggest replacing the pad.**

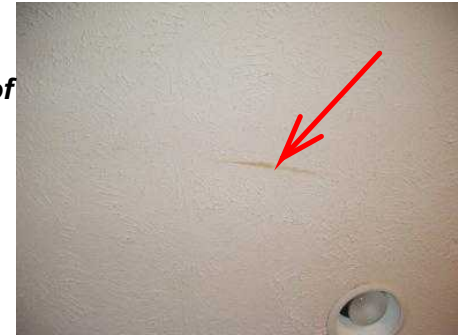
3. Main house Attic Insulation Depth: **+14" Approx R35**  
Interior Common Rooms
4. All interior finished common rooms Living Space Walls / Ceilings **Two water stains at ceiling of Kitchen. One area has minor drywall damage. Area tested dry today, appears to have been caused from snow blowing into roof vent. Suggest you ask owner about this.**

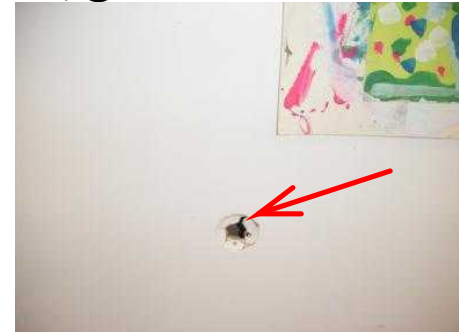
5. Master Bedroom Living Space Windows: **Cracked glass and defective thermal seal, @ one widow.**
6. Right Bedroom Living Space Walls / Ceilings **Hole at drywall behind door.**

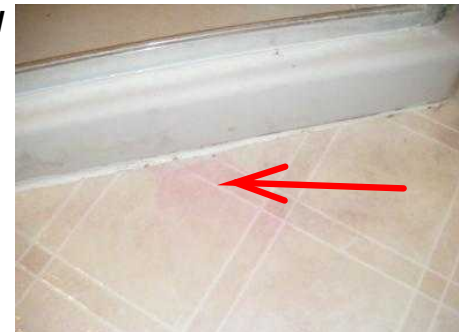
7. Master Bathroom Toilets: **The toilet is loose at the floor and will require replacement of the wax seal**
8. Basement Bedroom Bath Bathroom Shower/Surround: **Vinyl floor is discolored around shower, probably due to leakage from shower door.**

**Drywall stained, possible mold present at drywall next to shower. Drywall tested damp.**

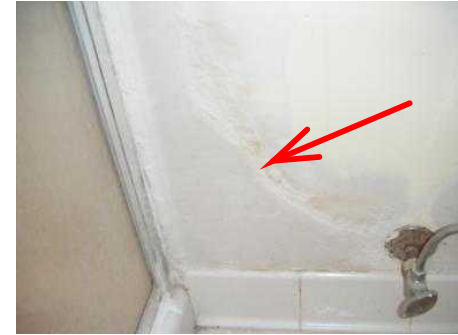
9. Basement Bedroom Bath Bathroom Ceilings/Walls/Floors: ***Finished Drywall next to shower has been repaired, appears there has leakage in this area. Potential mold present in area. Some parts of wall tested damp with moisture meter.***

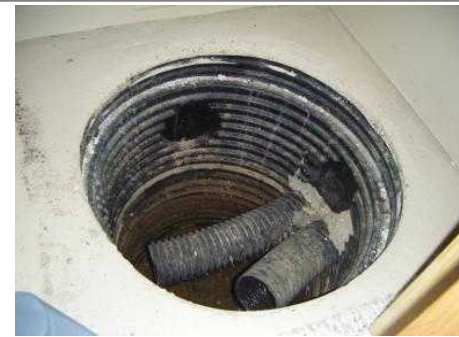
10. Main Basement Sump Pit/Pump: ***Pit located at the basement floor - no pump installed. Sump pit has a significant amount of water in it, recommend a sump pump be installed.***

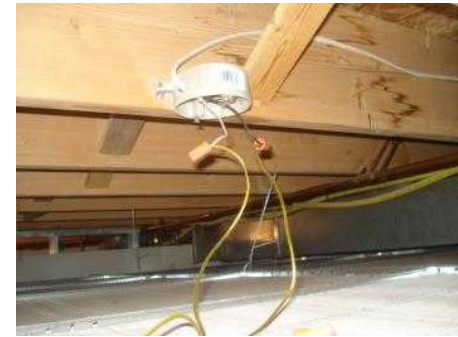
4. 120 VAC Branch Circuits: **Copper Electrical splice out of junction box at storage room ceiling.**

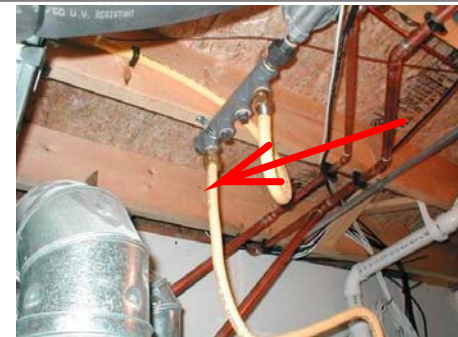
5. Gas Service Lines: **CSST Gas Pipe and Black Pipe. CSST Gas pipe used in home. Some local gas companies are requiring these pipes to be grounded, for safety concerns, due to lightning strikes. Recommend grounding by a licensed electrician or other licensed contractor.**
