# Home Inspection

300 Sample Street  
300 Sample  
Omaha, Ne

Prepared for: John Doe

Prepared by: Home Standards Inspection Services  
13512 Shongaska Road  
Omaha, NE 68112

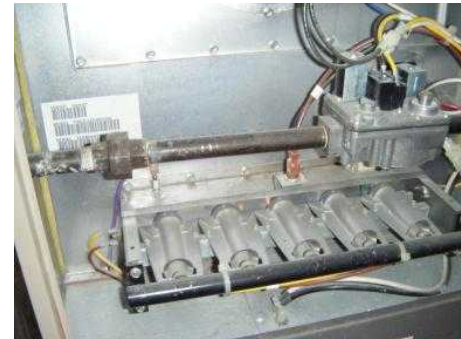
Basement Heating System

- Heating System Operation:
- General Condition **A carbon monoxide test was performed on the air coming from the furnace and no abnormal levels were observed.**
- Manufacturer: **Carrier FV4ANB006**
- Type: **Forced air** Capacity: **110,000 BTU**
- Area Served: **Entire house** Approximate Age: **5 yrs.**
- Fuel Type: **Natural gas**
- Heat Exchanger: **5 Burner**

Unable to Inspect: **90%**

- Blower Fan/Filter:
- Flue Pipe:
- Controls:
- Humidifier: **The humidifier pad is corroded. Suggest replacing the pad.**
